CLIENT: **QUIK-THERM INSULATION SOLUTIONS**
1680 Sargent Ave, Unit 3
Winnipeg, MB
R3H 0C2

Test Report No: T1035-4

SAMPLE ID: 152 mm (6 inches) Quik-Therm Solar Dry Insulation with plywood strapping and horizontal fiber cement board lap siding, described as non-combustible.

This report documents the fire testing conducted by QAI Laboratories Ltd. for Quik-Therm Insulation Solutions of a 152 mm (6 inches) Quik-Therm Solar Dry Insulation with plywood strapping and non-combustible horizontal fiber cement board lap siding.

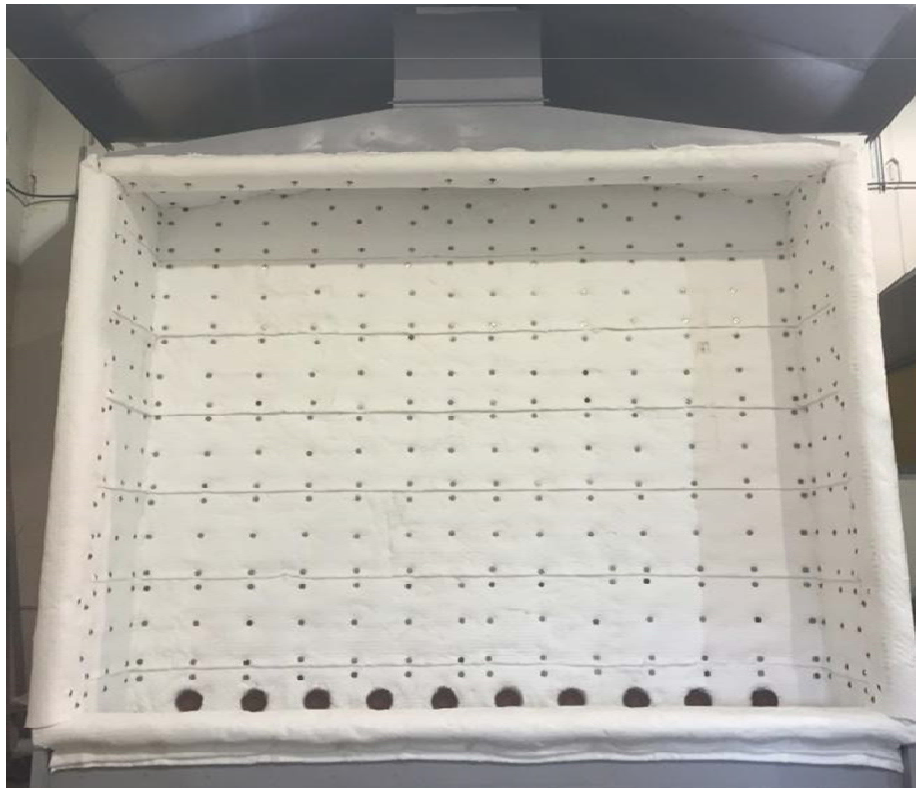
Figure 1: Full Scale Furnace

The furnace used in the test is a full-scale fire burning apparatus with interior dimensions of 3.96 m (13 ft.) in height, 3.96 m (13 ft.) in width, and 0.91 m (3 ft.) in depth.

Temperatures within the furnace were monitored using nine thermocouples (TCs). The temperatures are controlled by adjusting fuel to the furnace burners to conform to the time/temperature curve specified by the test standards. Temperature measurements are recorded by a Keithley 2750 data acquisition unit (ID# DMM1) which passes the readings to a computer for graphical display and storage.

The wall assembly was mounted in a vertical steel test frame. The test frame was then rolled up to the furnace and secured by chain and straps to the furnace opening. At the end of the test, the test frame was rolled away from the furnace so that the exposed face can be evaluated.

Two pressure taps are installed along the longitudinal center line of the test assembly. The pressure taps are each attached and monitored by Setra model 264 pressure transducers (ID# Pressure T1 and Pressure T2). The furnace pressure is controlled by adjusting a damper in the furnace exhaust stack. The furnace pressure was recorded continuously for the duration of the test.

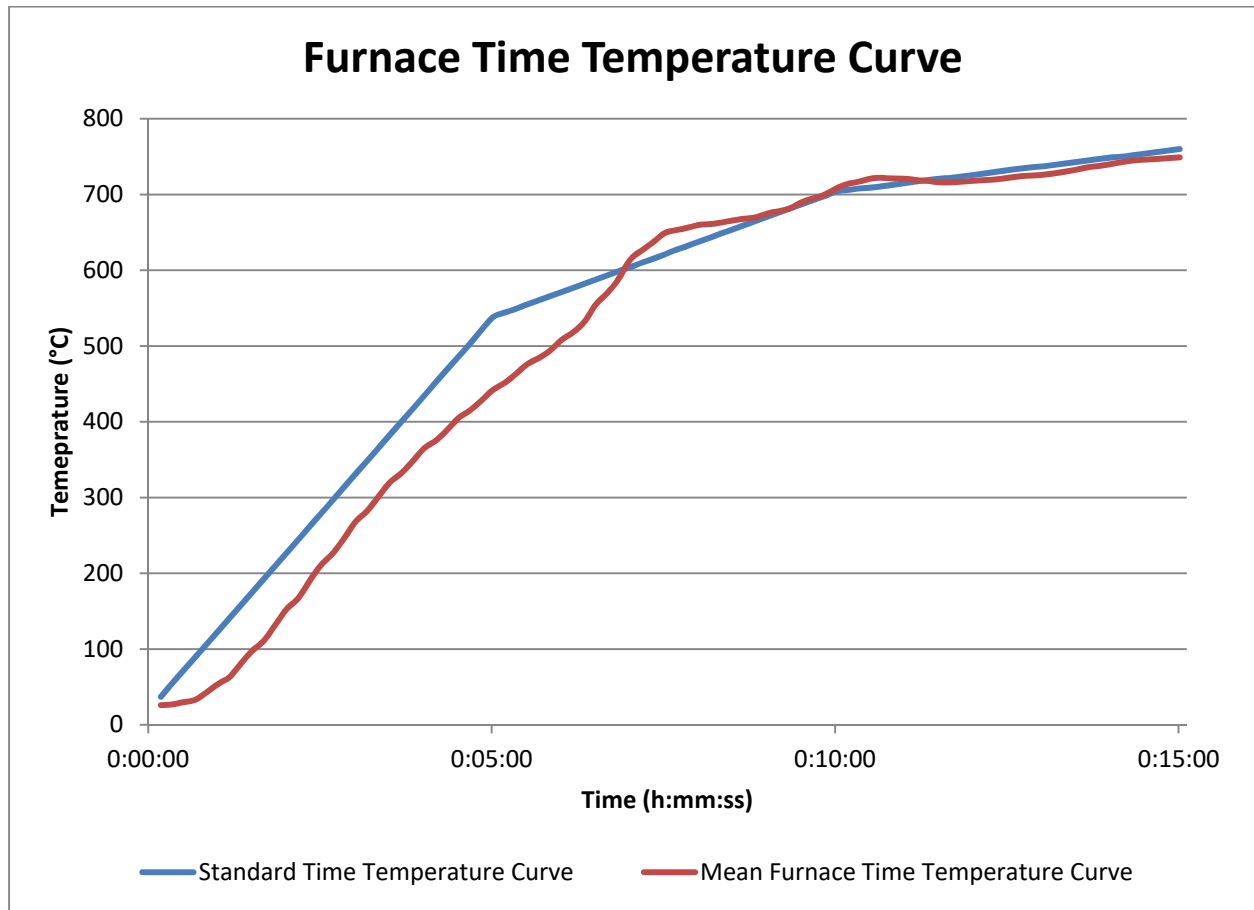
Figure 2: Furnace Time Temperature Curve

Prior to the fire endurance test the test assembly was moved into position in front of the furnace and the pilot burners were ignited. The fire endurance test was initiated after igniting the burners. The temperature inside the furnace was controlled to follow the standard time/temperature curve within the limits described in CAN/ULC S101.

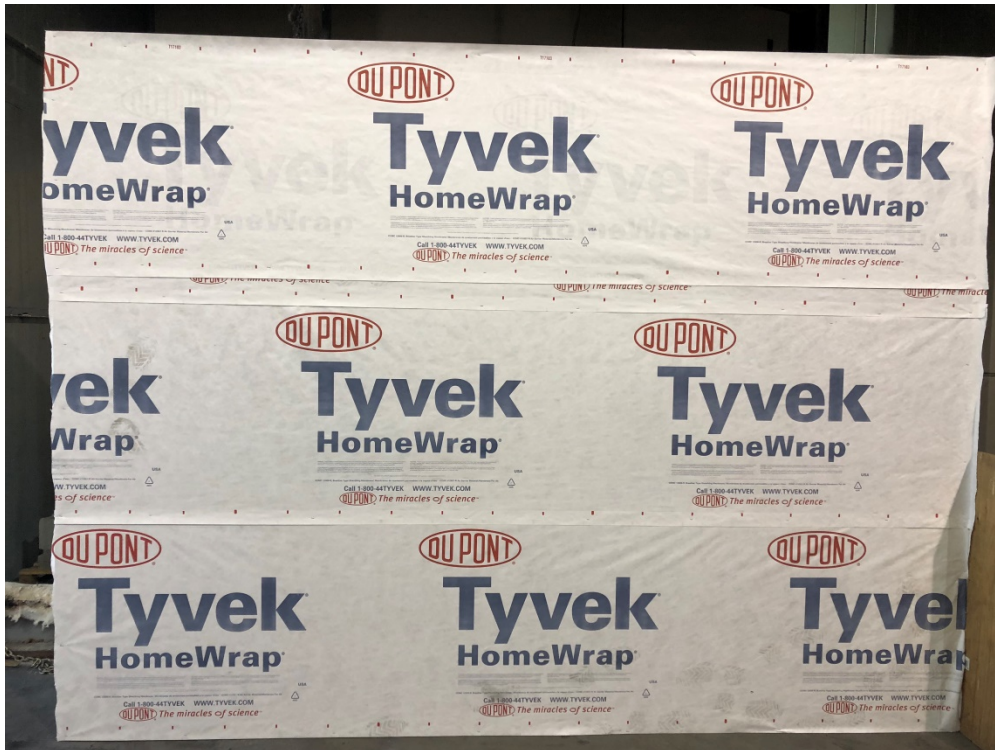
Figure 3: The exposed face prior to installing the Quik-Therm Solar Dry Insulation.

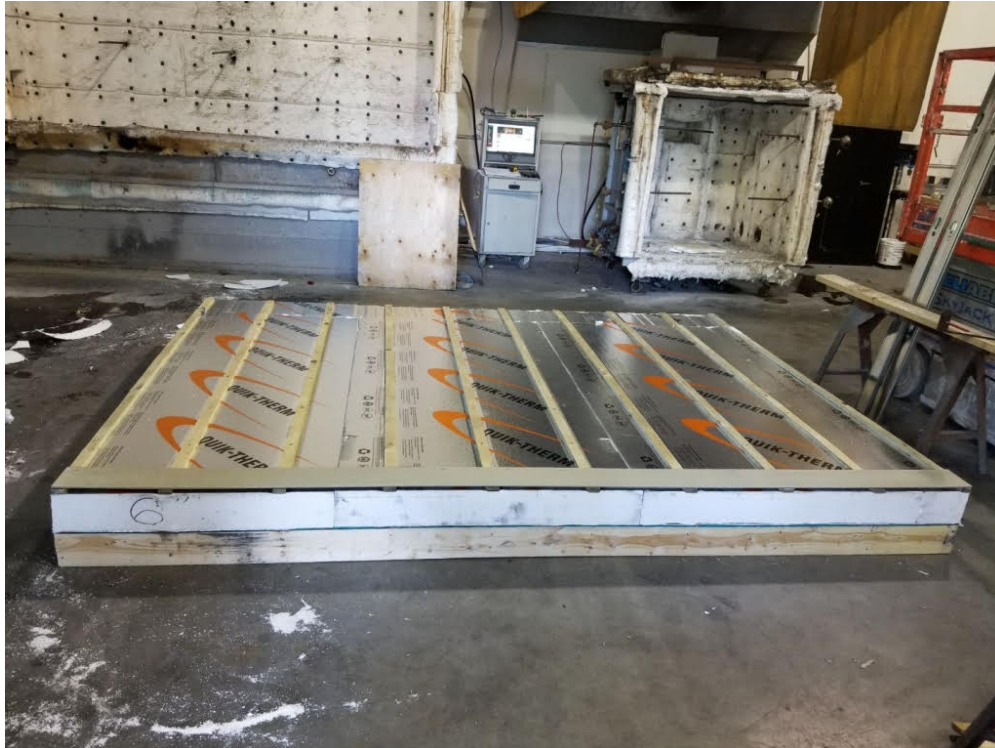
Figure 4: The exposed face prior to installing the cement board lap siding.

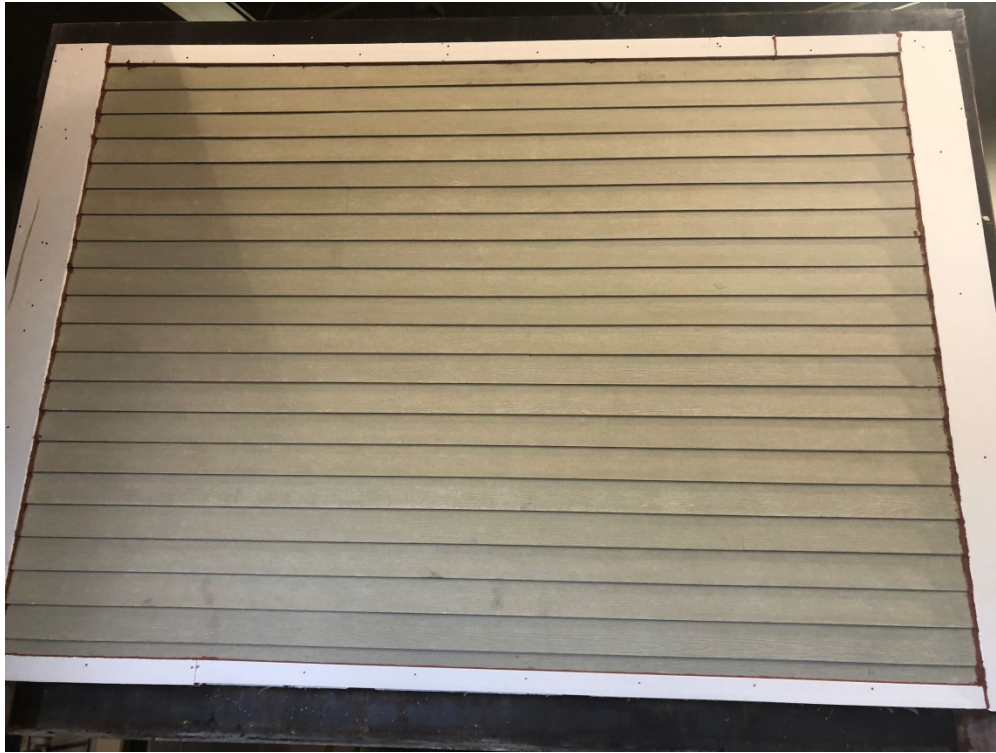
Figure 5: The exposed face prior to the fire test.

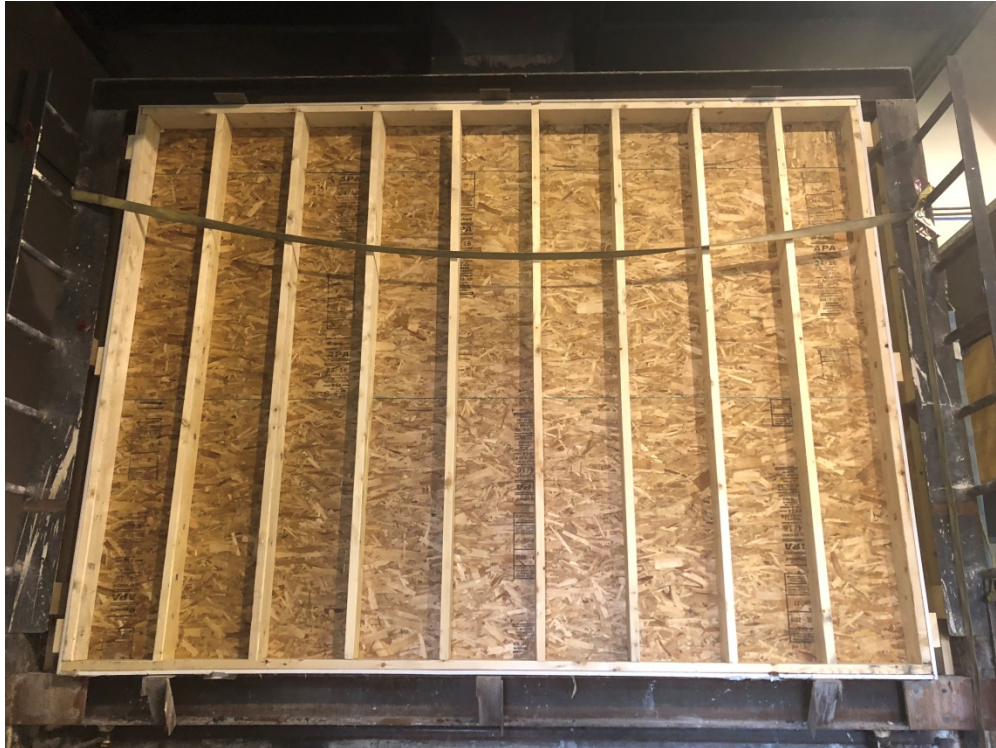
Figure 6: The unexposed face prior to the fire test.

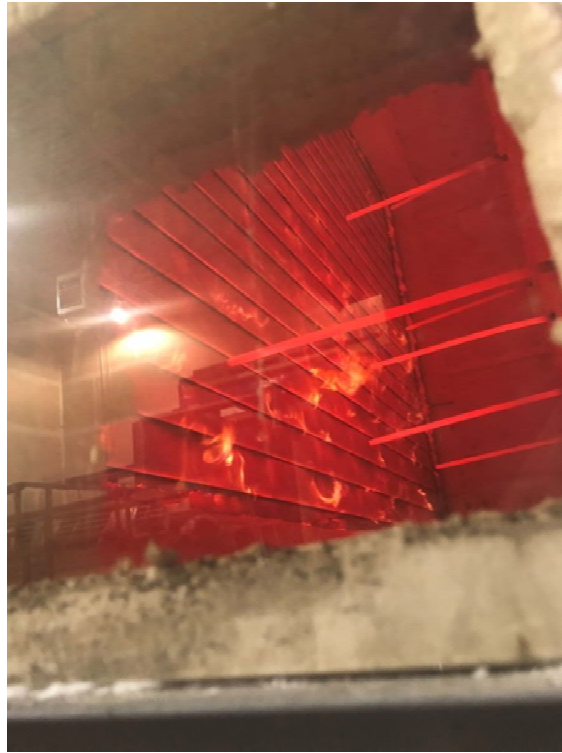
Figure 7: The exposed face at the end of the fire test.

After the wall was rolled away from the furnace it was observed that there were no openings in the fiber cement board siding. The joints and cracks remained tight. There were no signs of molten foam dripping and flaming on the outside of the wall structure. After extinguishing the wall and removing the cement board siding it was apparent that the foam plastic was absent from the wall. Only a small amount of plastic remained in the bottom of the cavity.

The fiber cement board siding remained in place for the duration of the test. The joints and cracks that formed in the surface of the board remained tight together. There were no visible openings in the exposed face when viewed normal. There was no structural deterioration of the fiber cement board siding.

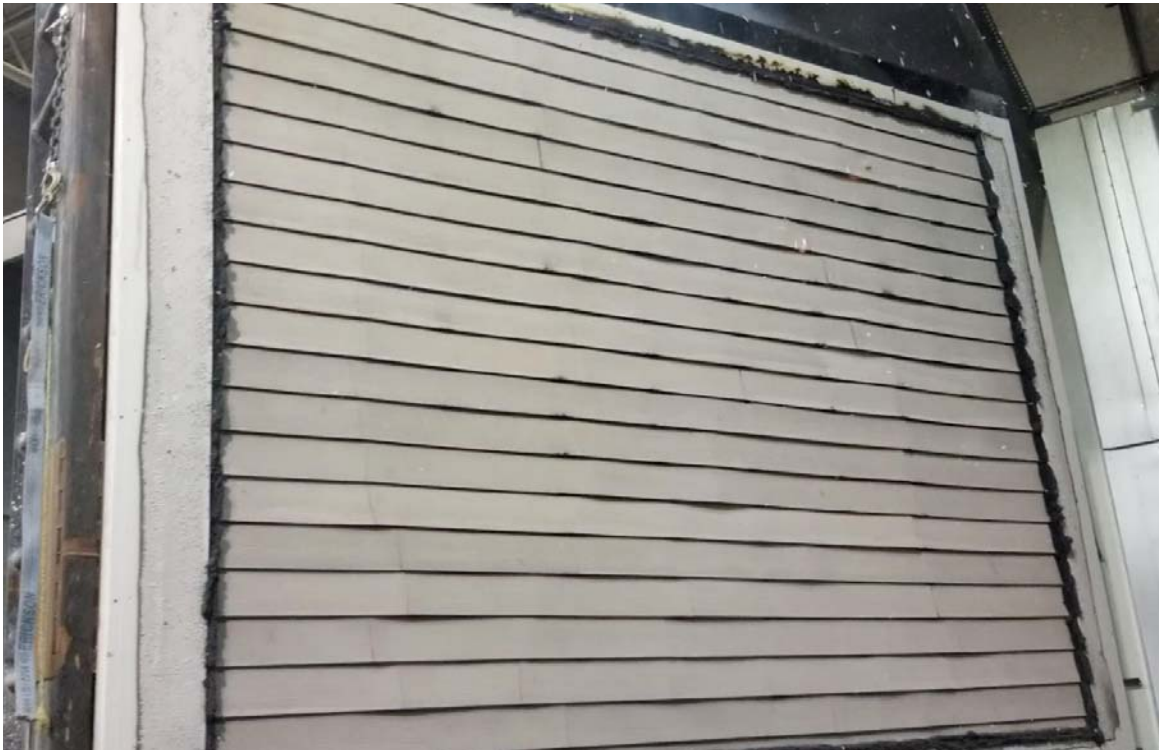
Figure 8: Exposed face after the fire test.
